**A Cursory Examination of a Parachute Bag Knife,
P/N 71172**

ARL-TR-3892

September 2006

14. ABSTRACT A parachute bag knife was received for a "quick-look" analysis to determine the reason for edge deformation after normal use. The U.S. Army Research Laboratory performed hardness testing, chemical analysis, and metallography. Hardness testing in conjunction with metallography showed a layer of decarburization around the periphery of the knife (not on the blade edge, however). Chemical analysis verified alloy AISI 4130 was used. Metallography also revealed a less than optimal microstructure for this alloy. It was recommended that future parts be quenched and tempered to produce a tougher knife edge.

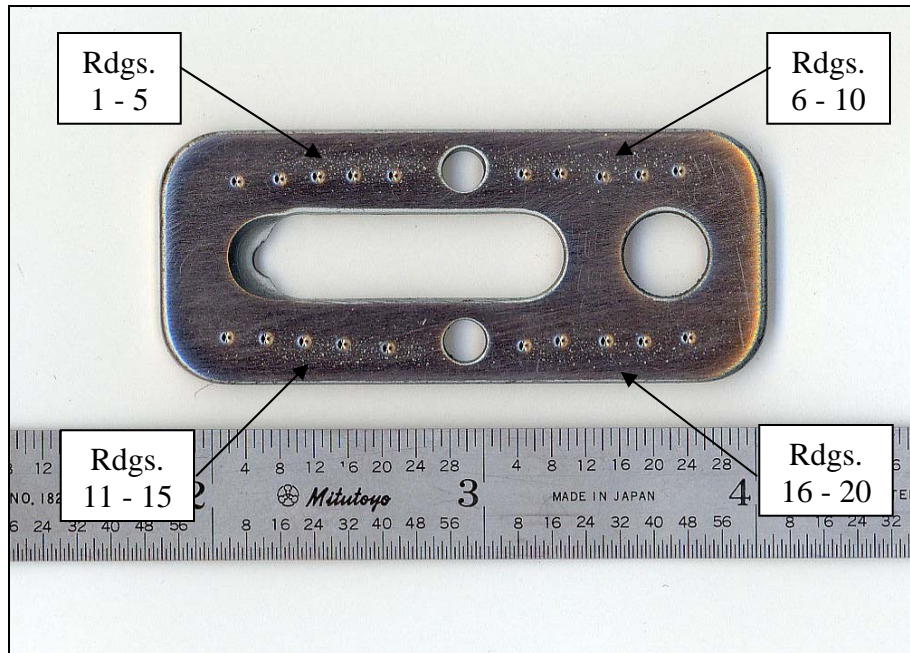
The part was lightly sanded utilizing 180-grit silicon carbide paper to remove the zinc coating. Care was taken not to heat the part, so as not to affect the structure of the steel. Hardness measurements using the Rockwell “C” scale (150 kgf) were taken along the periphery of the component, as shown in figure 4. As the results in table 1 indicate, this part was rather soft for an ultrahigh-strength steel alloy (AISI 4130). There is no hardness requirement on the engineering drawing.

Figure 4. Hardness measurements taken directly on the component (magnified 1.4×).

Reading	HRC	Reading	HRC
1	21.9	11	21.7
2	21.3	12	21.2
3	21.2	13	22.2
4	21.5	14	21.0
5	21.0	15	21.0
6	20.8	16	21.1
7	20.6	17	21.4
8	21.0	18	21.0
9	21.3	19	20.9
10	20.7	20	20.9
Average = 21.2 HRC

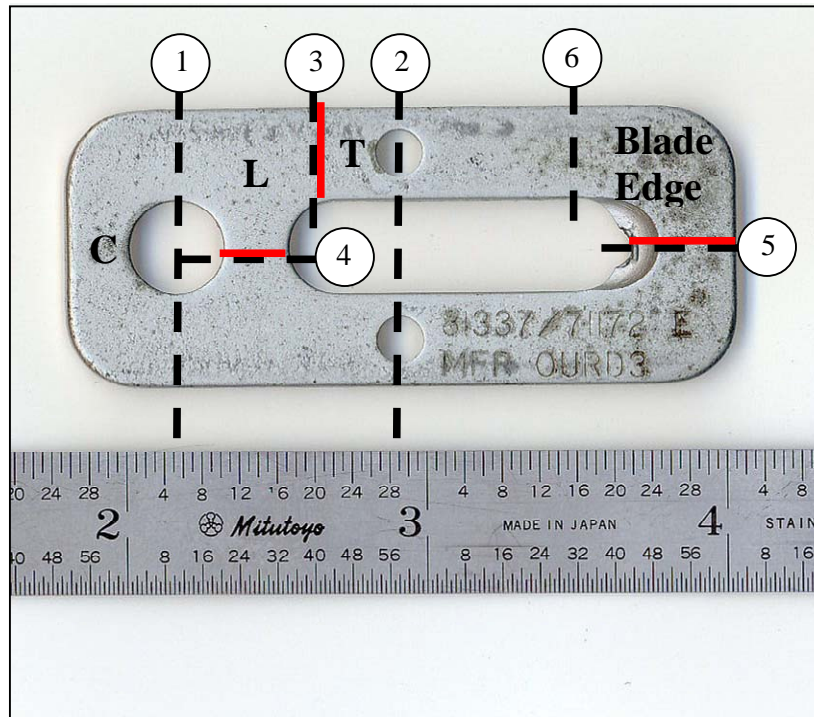
A section of the component (sectioning diagram shown in figure 5) was analyzed for chemical composition using wet chemistry techniques. The carbon and sulfur were detected utilizing the Leco combustion method, while the remaining elements were detected through direct current plasma spectroscopy. Governing specification SAE-AMS 6370¹ requires the chemical composition listed in table 2 for the AISI 4130 steel. As shown, the part met the requirements for AISI 4130.

Figure 5. Sectioning diagram showing chemical analysis sample (C), longitudinal metallography sample (L), transverse metallography sample (T), and blade tip metallography sample. Dashed lines represent sectioned areas, red lines represent prepared planes (magnified 1.75 \times).

The pieces shown in figure 5 representing the longitudinal and transverse directions (as related to the length of the part) were metallographically prepared. The samples were ground on silicon carbide papers ranging in grit size from 240 to 2400. Rough polishing using 1- μ m diamond

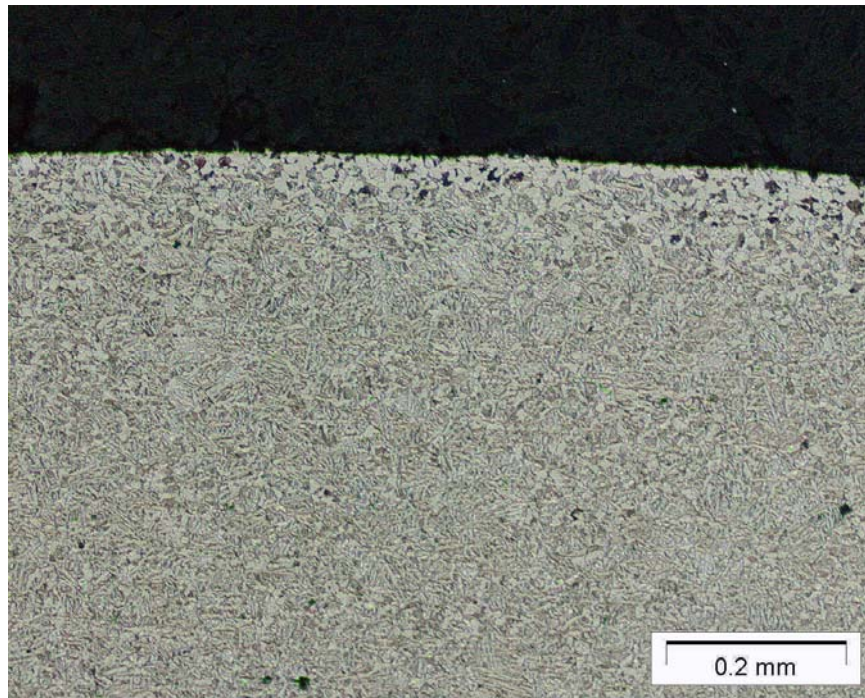
The grain size was measured using the micrograph in figure 7 (100 \times) in conjunction with overlay slides conforming to ASTM E112. The average grain size was found to be approximately ASTM No. 9.5. Evidence of decarburization existed, as shown in figure 8. This condition (denoted by a predominance of ferrite at the surface) was prevalent around the periphery of the entire part.

Figure 7. Micrograph used to measure grain size. ASTM E112 overlays were used to determine an average grain size of ASTM No. 9.5. Note evidence of banding. Etchant: 2% nital. (Magnified 100 \times .)

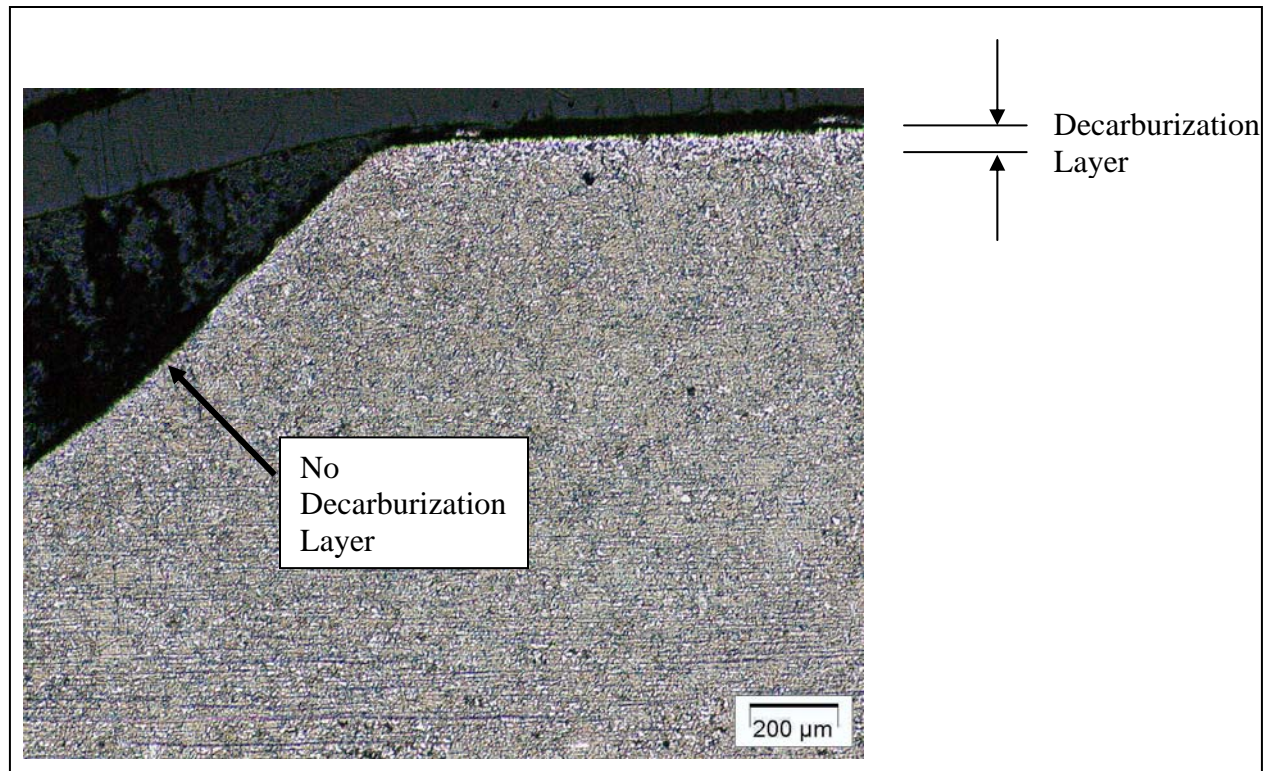
The sample consisting of a section made directly through the tip of the blade was also metallographically prepared as previously described. The intent was to determine if the manufacturer had ground the blade after heat treatment. Figure 9 shows the interface between the exterior surface of the knife and the blade tip. Note the layer of decarburization along the surface of the component, which ends where the blade begins. This was evidence that the manufacturer did indeed grind the blade after heat treatment. Figure 10 shows the deformed tip of the blade, while figure 11 (magnified view of figure 10) shows the grain flow within the tip.

Figure 9. Decarburization at the surface of the component, but not on the blade edge. This shows manufacturer ground the blade after heat treatment. Etchant: 2% nital. (Magnified 50×.)

In general, knives are manufactured from quenched and tempered steel, resulting in a fine lath martensite microstructure. This is a much harder and tougher microstructure than pearlite and ferrite. It is recommended that future production of this component entail quenching and tempering of this alloy (per acceptable industry standards) to produce a part with a hardness in the upper 30's to lower 40's HRC. Heat treatment and hardness requirements should be added to Engineering Drawing 71172 to ensure quality components in the future. The U.S. Army Research Laboratory can provide assistance in this area if the U.S. Army Natick Research, Development and Engineering Center so chooses. In addition, it should be a requirement that the blade tip be ground after heat treatment. This would prevent decarburization from softening the tip.

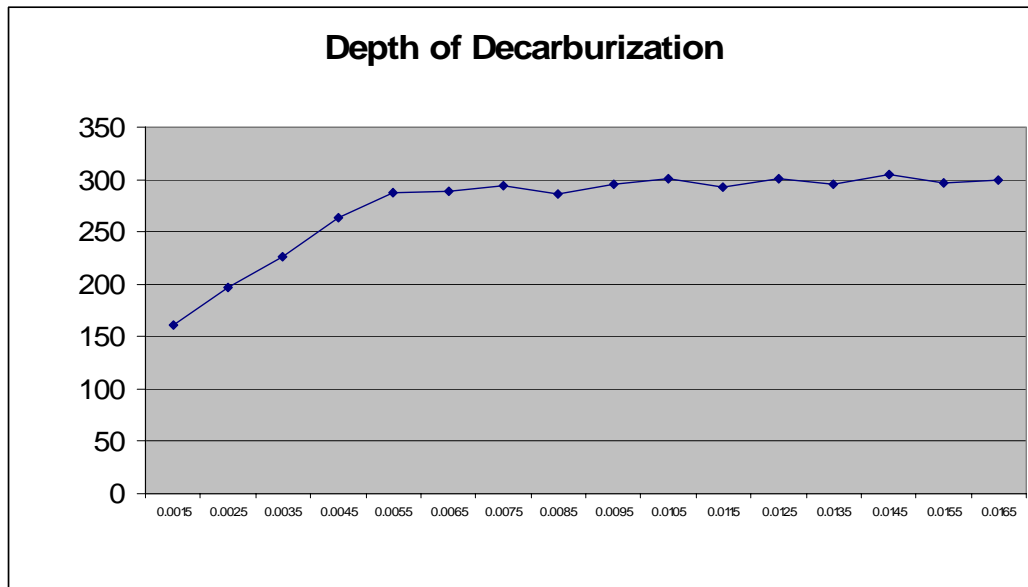
A metallographically prepared sample was subjected to Knoop microhardness to determine the extent of the decarburization layer. As the governing specification indicates, the total depth of decarburization shall not exceed 0.010 in for parts with a nominal distance between parallel sides less than 0.375 in (3.3.4.3). Table 3 contains the results of microhardness testing. As shown, the first four hardness readings were well below those of the remainder of the part (highlighted in red), indicating a depth of decarburization of ~0.0055 in. This was well within the 0.010-in requirement. Figure 12 shows a graphical representation of the Knoop microhardness readings, while figure 13 shows Knoop microhardness indents through the decarburization into the core.

Reading	HK	Approx. HRB/HRC	Depth From Surface
1	161.0	79.0 HRB	0.0015
2	197.6	89.3 HRB	0.0025
3	226.3	95.0 HRB	0.0035
4	264.1	22.6 HRC	0.0045
5	287.5	26.5 HRC	0.0055
6	289.3	26.8 HRC	0.0065
7	294.6	27.6 HRC	0.0075
8	286.0	26.3 HRC	0.0085
9	296.1	27.8 HRC	0.0095
10	300.3	28.4 HRC	0.0105
11	292.3	27.3 HRC	0.0115
12	300.3	28.4 HRC	0.0125
13	295.3	27.7 HRC	0.0135
14	304.7	29.1 HRC	0.0145
15	297.2	28.0 HRC	0.0155
16	298.8	28.2 HRC	0.0165

Figure 12. Plot of Knoop microhardness vs. depth below surface. Decarburization was determined to be ~0.0055 in deep.

It should be noted that the component core hardness level differs from the Rockwell “C” readings reported earlier in this report. This is most likely due to the fact that the decarburization layer deleteriously affected the Rockwell “C” readings. The readings listed in table 3 are a more accurate assessment of the component hardness. These readings compare favorably to the expected hardness of the microstructure noted.

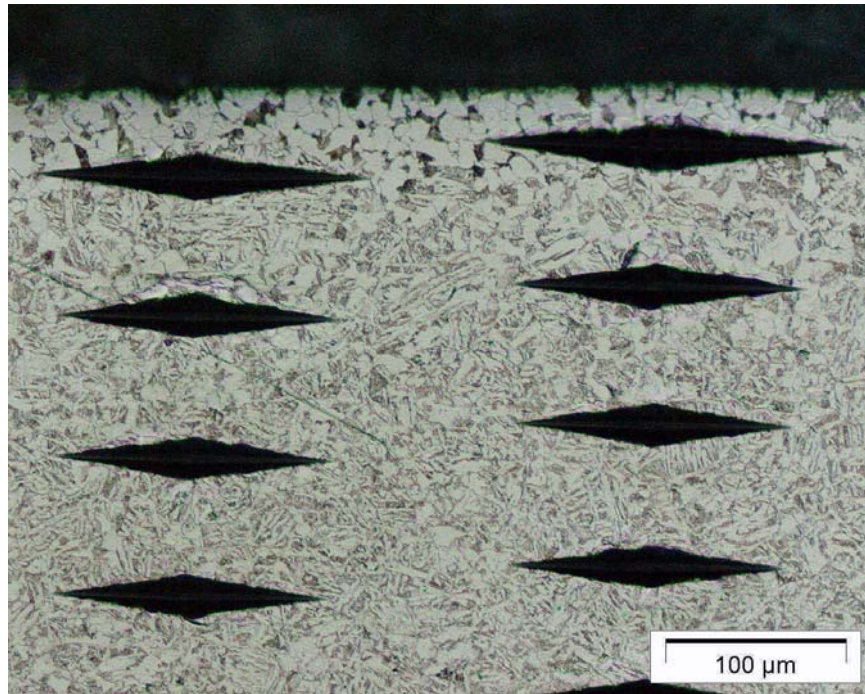
Figure 13. Knoop hardness indentations through the layer of decarburization at the surface of the component. Note the larger indents (indicating a softer material) within the decarburized region at the surface. Etchant: 2% nital. (Magnified 200×.)
